Challenger Disaster

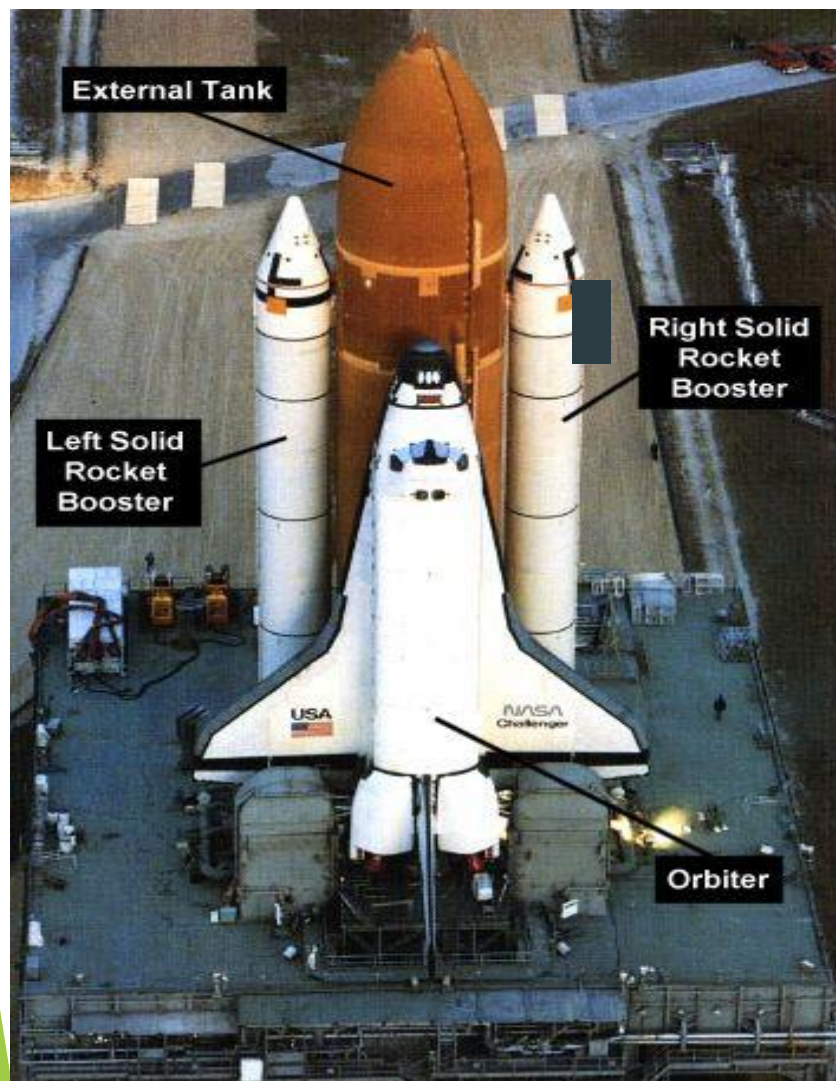
Basic shuttle design

The orbiter of the Challenger had three main engines fuelled by liquid hydrogen. The fuel was carried in an external fuel tank which was jettisoned when empty. During lift-off, the main engines fire for about nine minutes, although initially the thrust was provided by the two booster rockets. These booster rockets are of the solid fuel type, each burning a million pound load of aluminum, potassium chloride, and iron oxide.

The casing of each booster rocket is about 150 feet long and 12 feet in diameter. This consists of cylindrical segments that are assembled at the launch site. There are four-field joints and they use seals consisting of pairs of O-rings made of vulcanized rubber. The O-rings work with a putty barrier made of zinc chromate.

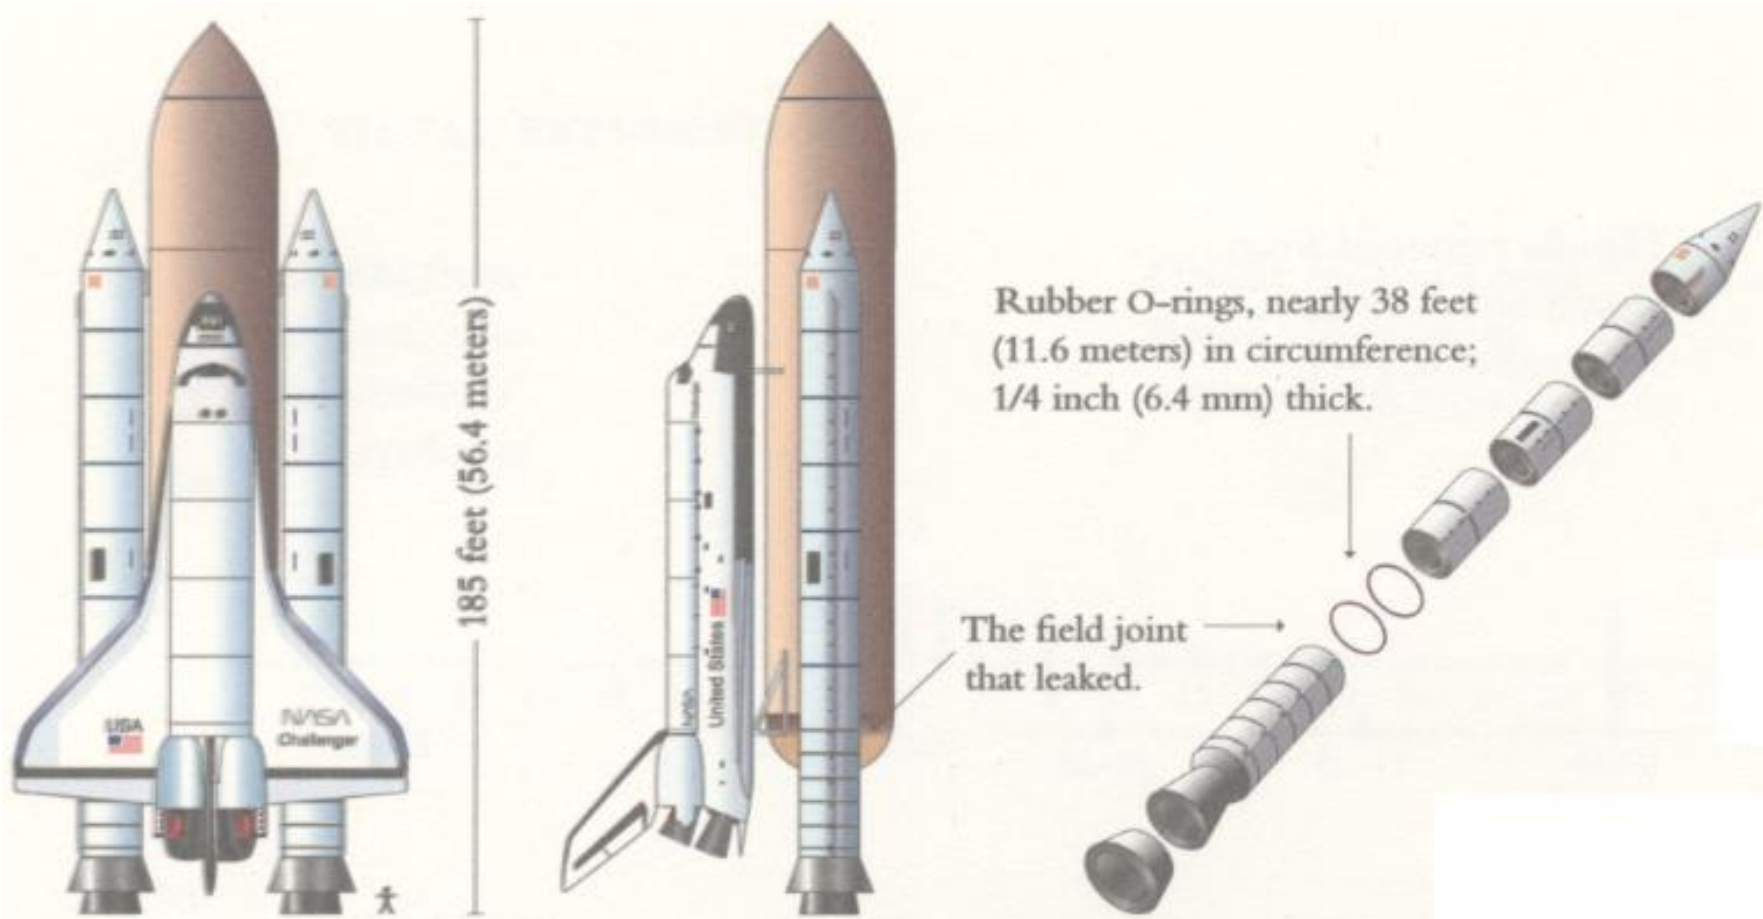
Challenger Model

The shuttle consists of an *orbiter* (which carries the crew and has powerful engines in the back), a large liquid-fuel *tank* for the orbiter engines, and 2 solid-fuel *booster rockets* mounted on the sides of the central tank.

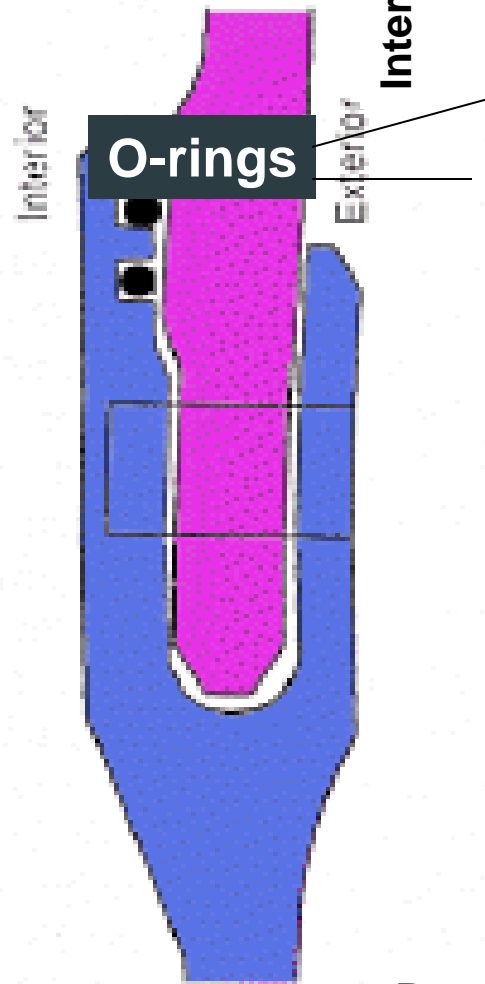
Pressurized Joint Deflection

Pressurised Joint deflection on Solid Rocket Booster

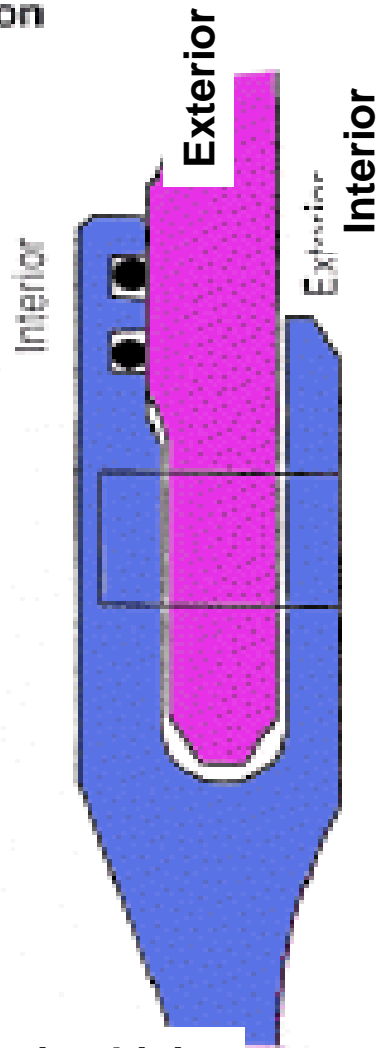
Pressurised joint
(exaggerated)

Pressurized Joint
(Exaggerated)

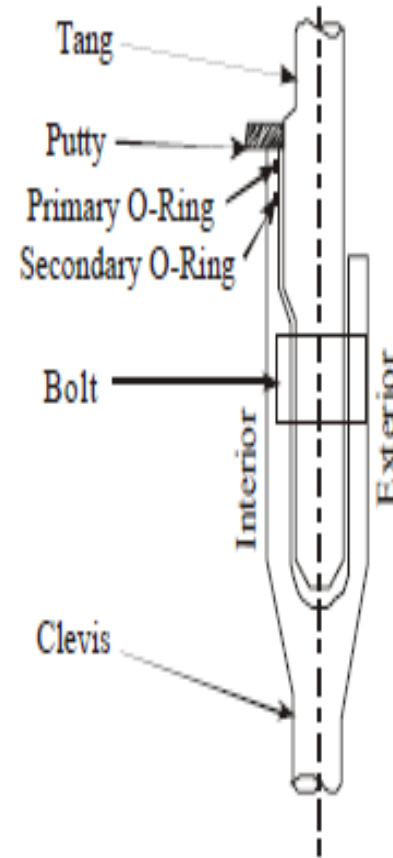
Fig. 3.2 b Field joint before ignition

- ▶ On many of the previous flights the rings have been found to have charred and eroded. In freezing temperature, the rings and the putty packing are less pliable.
- ▶ From the past data gathered, at temperature less than 65 °F the O-rings failure was certain.
- ▶ But these data were not deliberated at that conference as the launch time was fast approaching.

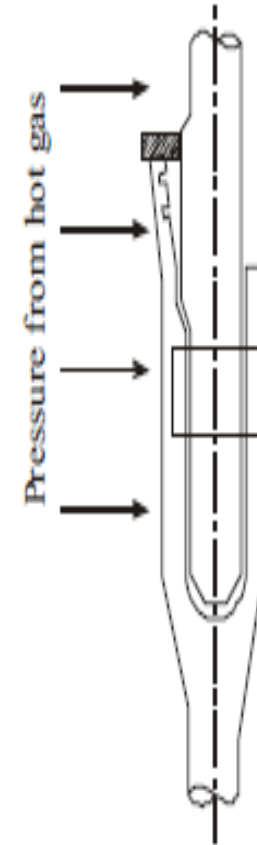
Fig. 3.2 c Field joint after ignition

- ▶ At 11.38 a.m. the rockets along with Challenger rose up the sky. The cameras recorded **smoke**
- ▶ **coming out of one of the filed joints** on the right booster rocket. Soon there was a **flame that hit the**
- ▶ **external fuel tank**. At 76 seconds into the flight, the Challenger at a height of 10 miles was totally
- ▶ **engulfed in a fireball**. The crew cabin fell into the ocean killing all the seven aboard.
- ▶ Some of the factual issues, conceptual issues and moral/normative issues in the space shuttle
- ▶ challenger incident, are highlighted hereunder for further study.
